## BELZONA® REPAIRS & PROTECTS PUMP

OEM PUMP SHOP  
Burnaby, BC

August 1989

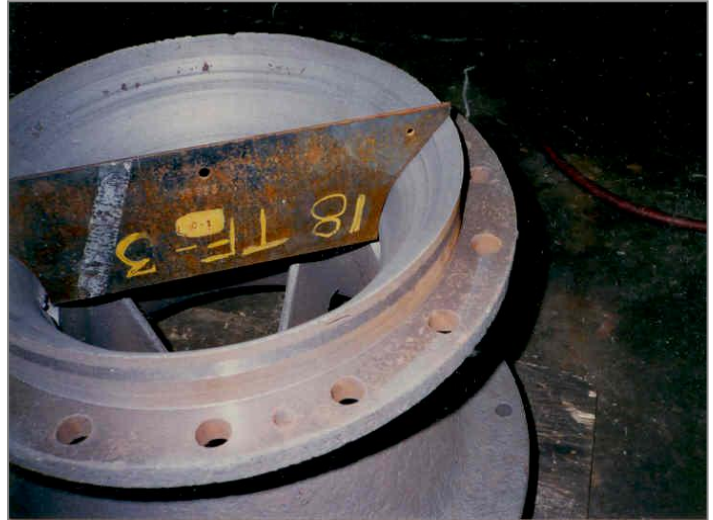
Erosion and a collapsed bearing had contributed to massive wear around diffuser bowl. Almost a ¼ inch of metal had been lost.

1. Pump bowl with template showing extent of rebuild required
2. Repairs to eroded and damaged areas in progress.
3. Completed application

Belzona® 1311 Ceramic R Metal  
Belzona® 1321 Ceramic S Metal
