BELZONA® REPAIRS & PROTECTS CAST IRON PUMP BOWL

OEM PUMP MANUFACTURER
Burnaby, BC

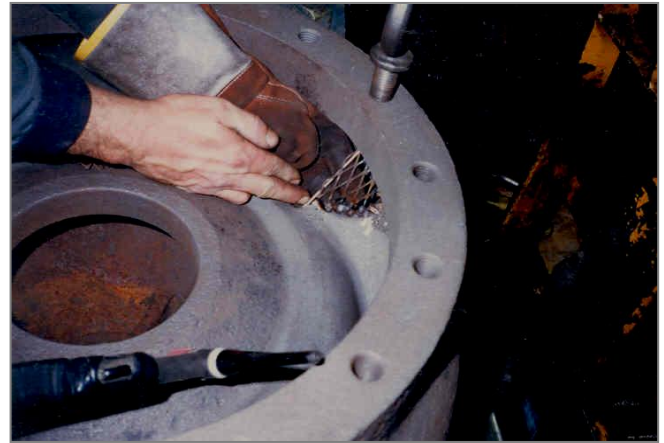
1. View of pump bowl with vanes under construction.
2. Reinforcement frame work for vanes completed.
3. Vanes rebuilt and entire bowl protected from further erosion corrosion.

Application carried out in accordance with Belzona® Know-How Leaflets CEP-1,5
