BELZONA® REBUILDS ERODED CORRODED TAILSHAFT

TUG BOAT OPERATOR
Vancouver, BC

August 1996

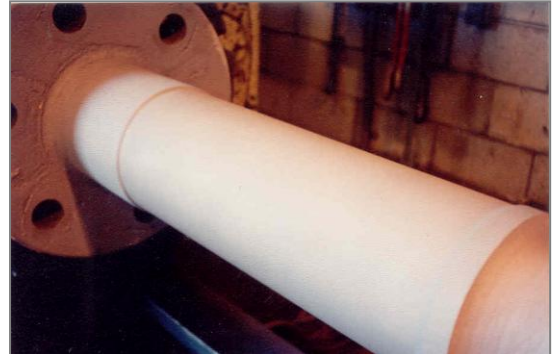
1. Shaft set up in lathe after under cutting and grit blasting
2. Application of Belzona® 1111 in progress.
3. 1st cut in progress.
4. Completed shaft repair
