BELZONA® REBUILDS AND PROTECTS KORT NOZZLE

TUG BOAT OPERATOR
Vancouver, BC

August 1995

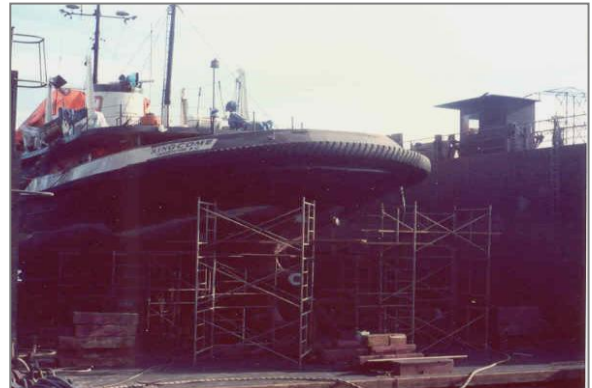
Bi-Metallic erosion

1. View of tug boat and Kort nozzle removed.
2. Application of 1st Coat of 1341 completed with application of 2nd coat in progress.
3. Application of 2nd coat completed.
4. Nozzle reinstalled. Plug areas rebuilt with Belzona®1311 prior to application of Belzona®1341.
