BELZONA® SAVES BRINE PUMP FROM THE SCRAP HEAP

RECREATION CENTER – HOCKEY RINK
British Columbia, Canada

Pump used to pump brine solution was slated for the scrap heap

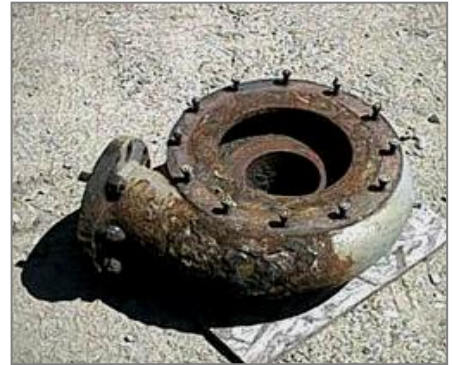
1. View of corroded pump body.
2. Pump casing after grit blasting to a near white metal finish.
3. Completed application with inside repaired and coated with Belzona® 1321 and the outside protected with Belzona® 5811 Immersion Grade
