BELZONA® REBUILDS AND PROTECTS KORT NOZZLES

TUG BOAT OPERATOR
Richmond, BC.

June 2005

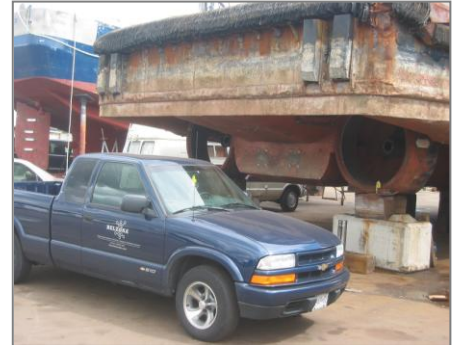
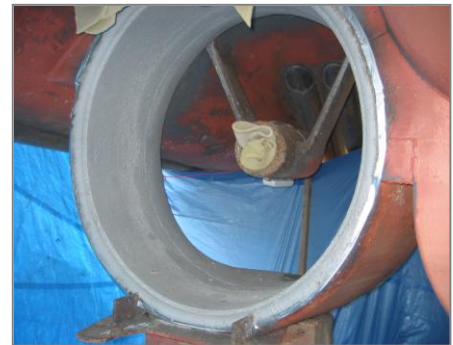
1. Blasting of the two nozzles completed (Inset: View of Tug boat)
2. Application of the 1st coat in progress. After this had set up for approximately 1 hour eroded areas were rebuilt.
3. Completed application
