## BELZONA® REBUILDS OVERSIZE PINTLE HOUSINGS

International Shipping Company  
Victoria, BC

November 2009

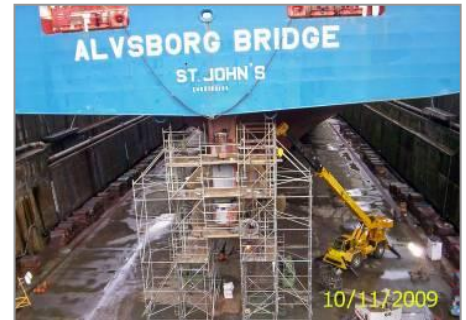
1. View of application site.
2. View of the vessel showing the size of the pintle housings and rudder horn. Main pintle had height of 530mm and diameter of 450mm. The upper pintle was 30% smaller
3. View of the upper pintle housing before it had been blasted and the new housing set in place.
4. After sealing off the bottom of the housing with Belzona® 1221 Super E Metal so that the material could not leak out, Belzona® 1321 Ceramic S Metal was injected into the void.
5. Application completed in approximately 4 hours.
