BELZONA® REBUILDS ERODED SONAR DOME FLANGES

Canadian Navy
Esquimalt, BC

May 2010

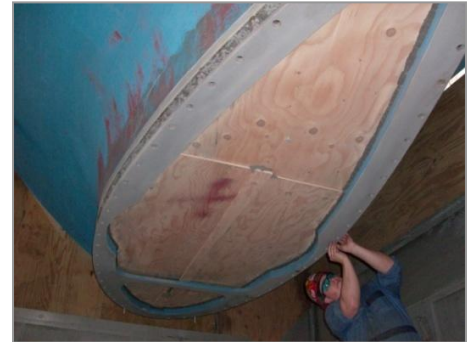
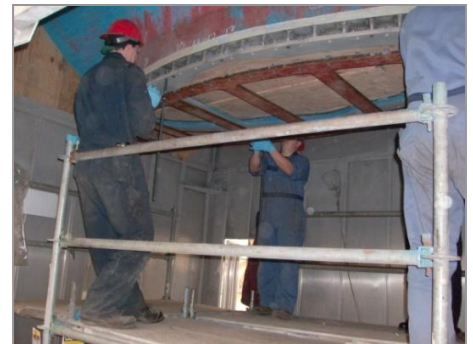
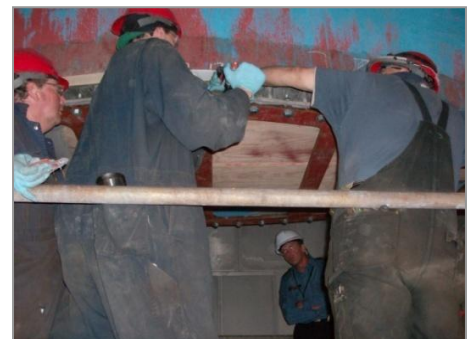
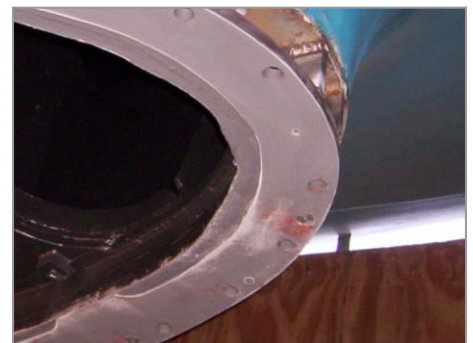
PHOTOGRAPHS

1. Pre-determined spacers are bonded to the flange to ensure that the slave flange can be accurately tightened against them.
2. The dummy flange coated with Belzona 9411 Release Agent is positioned a few inches below the hull flange and Belzona 1121 Super XL Metal is applied to both mating surfaces.
3. The former flange is then tightened systematically until it is hard against the spacers and level.
4. The reformed flange after the former has been removed and the edges cleaned up.

The mating flange on the underside of the vessel was eroded and warped making it difficult to install the new component effectively.

The use of Belzona enabled the ship yard to accurately reform the flange in place eliminating a major problem.
