BELZONA® 1341 SUPERMETALGLIDE IMPROVES PUMP PERFORMANCE

OEM PUMP MANUFACTURER

August 1996

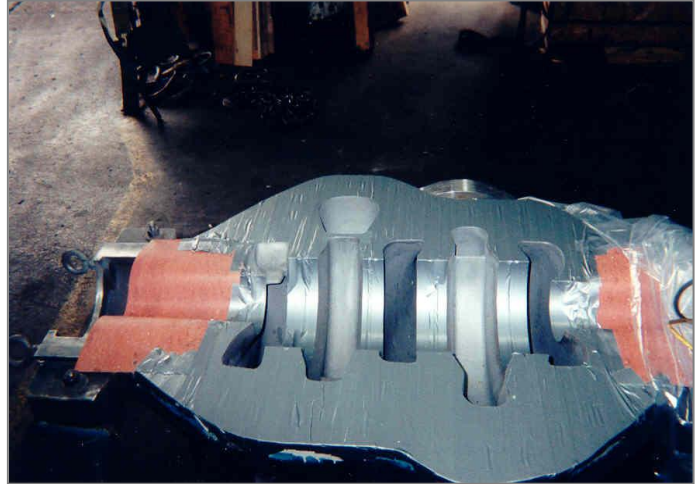
1. Pump casing grit blasted and ready for application of 1st of 3 coats. 1st coat applied was Belzona® 1321 Ceramic S Metal.
2. Application of 2nd coat Belzona® 1341
3. 3rd and final application of Belzona® 1341
